Special Flood Hazard Evaluation Report

Maumee River

Defiance and Paulding
Counties
Ohio

US Army Corps
of Engineers
Buffalo District

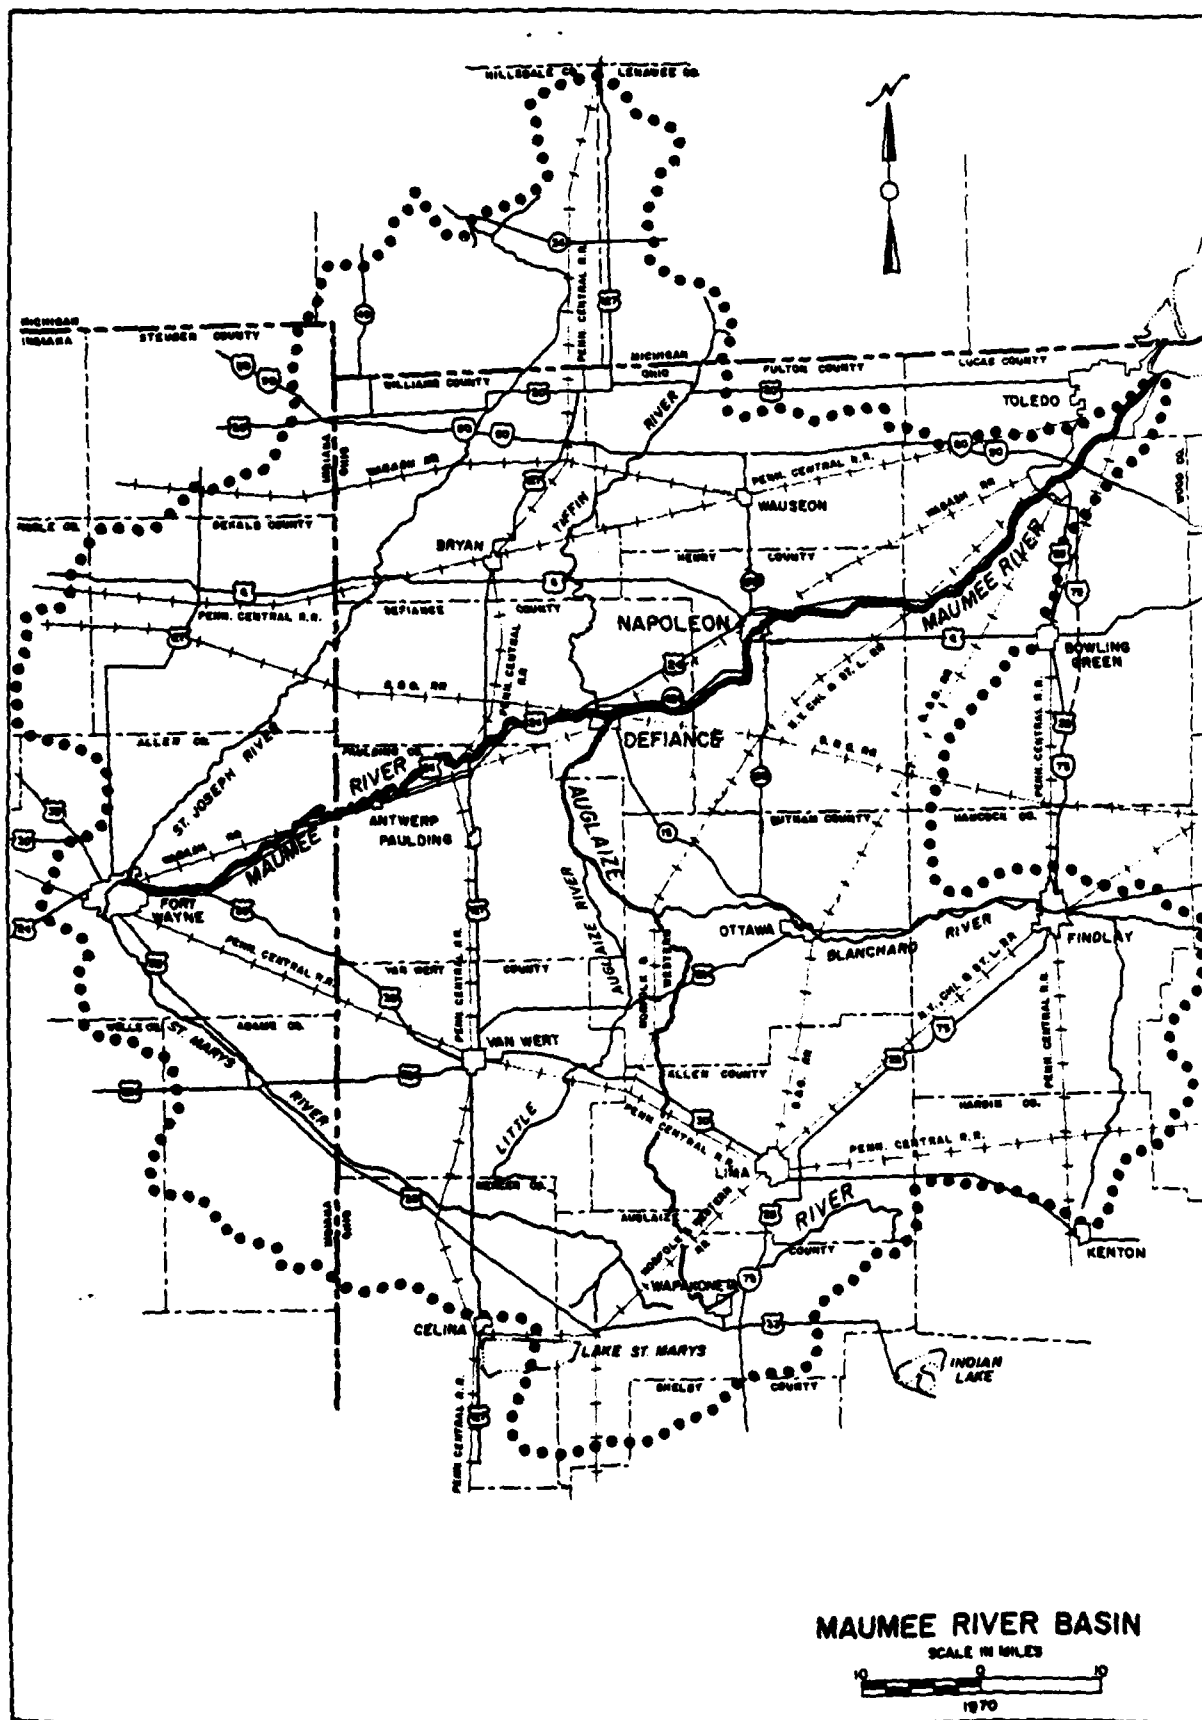
The total drainage area of the Maumee River is 6,608 square miles (see Figure 1). With its headwaters in Fort Wayne, Indiana, the Maumee River flows in a northeasterly direction through Ohio to Maumee Bay at Toledo. Two major tributary rivers, the Tiffin and the Auglaize, join the Maumee River at Defiance, Ohio. The Maumee River flows in a channel with large sweeping bends through flood plains that vary in width from a few hundred feet to about two thousand feet in width. Terrain varies from flat plains to moderately hilly uplands. Total fall of the river is 178 feet. Within the 52 mile study reach, the river has an average fall of 1.1 feet per mile.

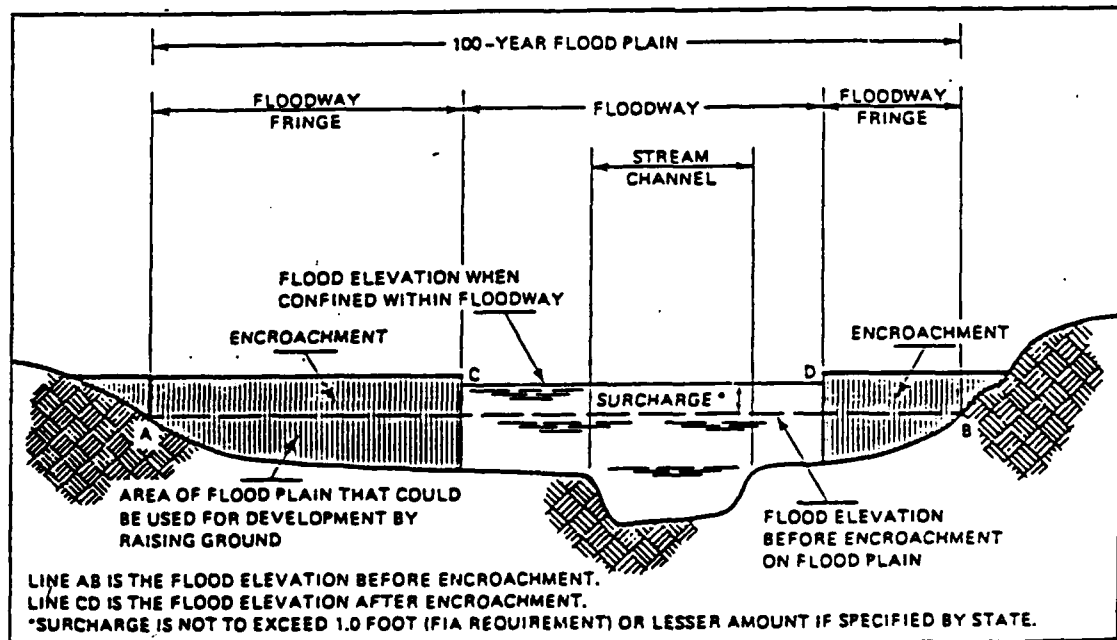
FIGURE 2 - Floodway Schematic

A flood plain consists of two useful zones. The first zone is the designated "floodway" or that cross sectional area required for carrying or discharging the anticipated flood waters with a maximum 1-foot increase in flood level (Ohio Department of Natural Resources standard). Velocities are the greatest and most damaging in the floodway. Regulations essentially maintain the flow-conveying capability of the floodway to minimize inundation of additional adjacent areas. Uses which are acceptable for floodways include parks, parking areas, open spaces, etc.

The second zone of the flood plain is termed the "floodway fringe" or restrictive zone, in which inundation might occur but where depths and velocities are generally low. Although not recommended if practicable alternatives exist, such areas can be developed provided structures are placed high enough or floodproofed to be reasonably free from flood damage during the Base (100-year) Flood. Typical relationships between the floodway and floodway fringe are shown in Figure 2. The floodway has been plotted on the Flooded Area Maps, Plates 6 through 13.

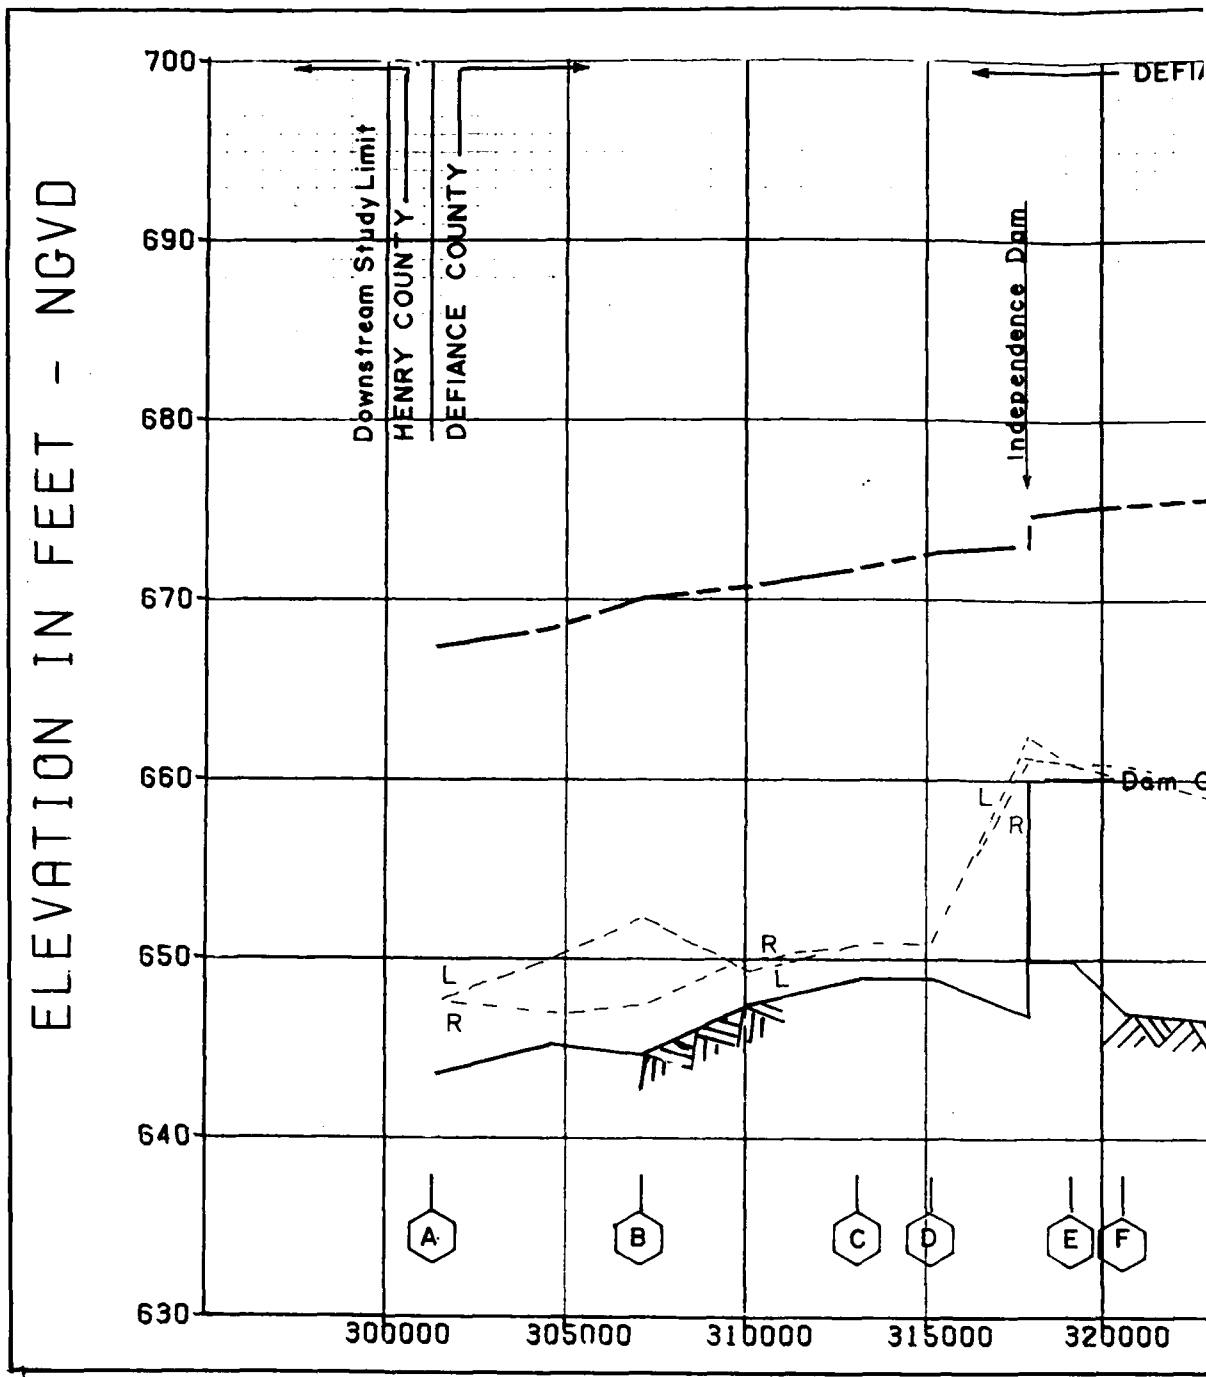
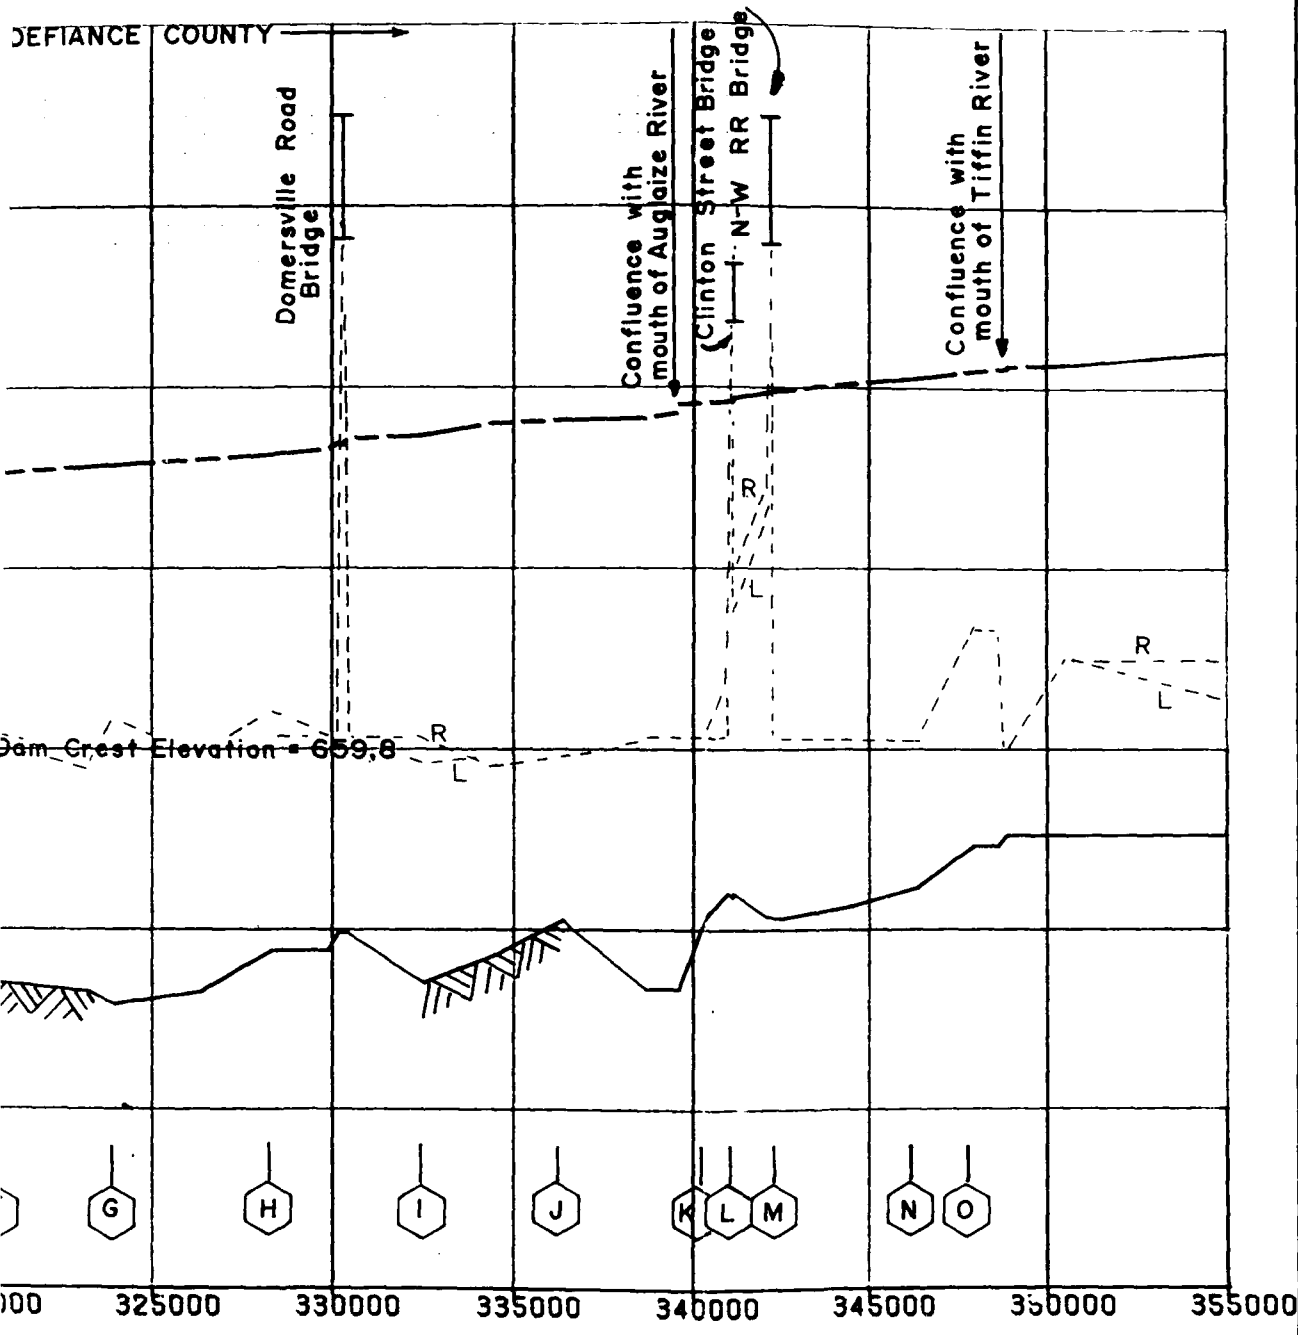
PLATE I

Distance is measured in feet from the mouth of Maumee River at Lake Erie.

FLOOD PROFILE MAUMEE RIVER

DEFIANCE AND PAULDING COUNTIES, OHIO
 STATION 3014+20 - 3550+00

Locations of selected cross sections used in the hydraulic analyses are shown on the Flood Profiles (Plates 1-5). Selected cross section locations are also shown on the Flooded Area Maps (Plates 6-13).

The computed 100-year water surface profile for the Maumee River in Defiance and Paulding Counties is shown on Plates 1-5. The flood plain boundaries are shown on Plates 6-13. These boundaries were delineated using the flood elevations determined at each cross section. Between cross sections, the boundaries were interpolated using USGS topographic maps and spot elevations obtained

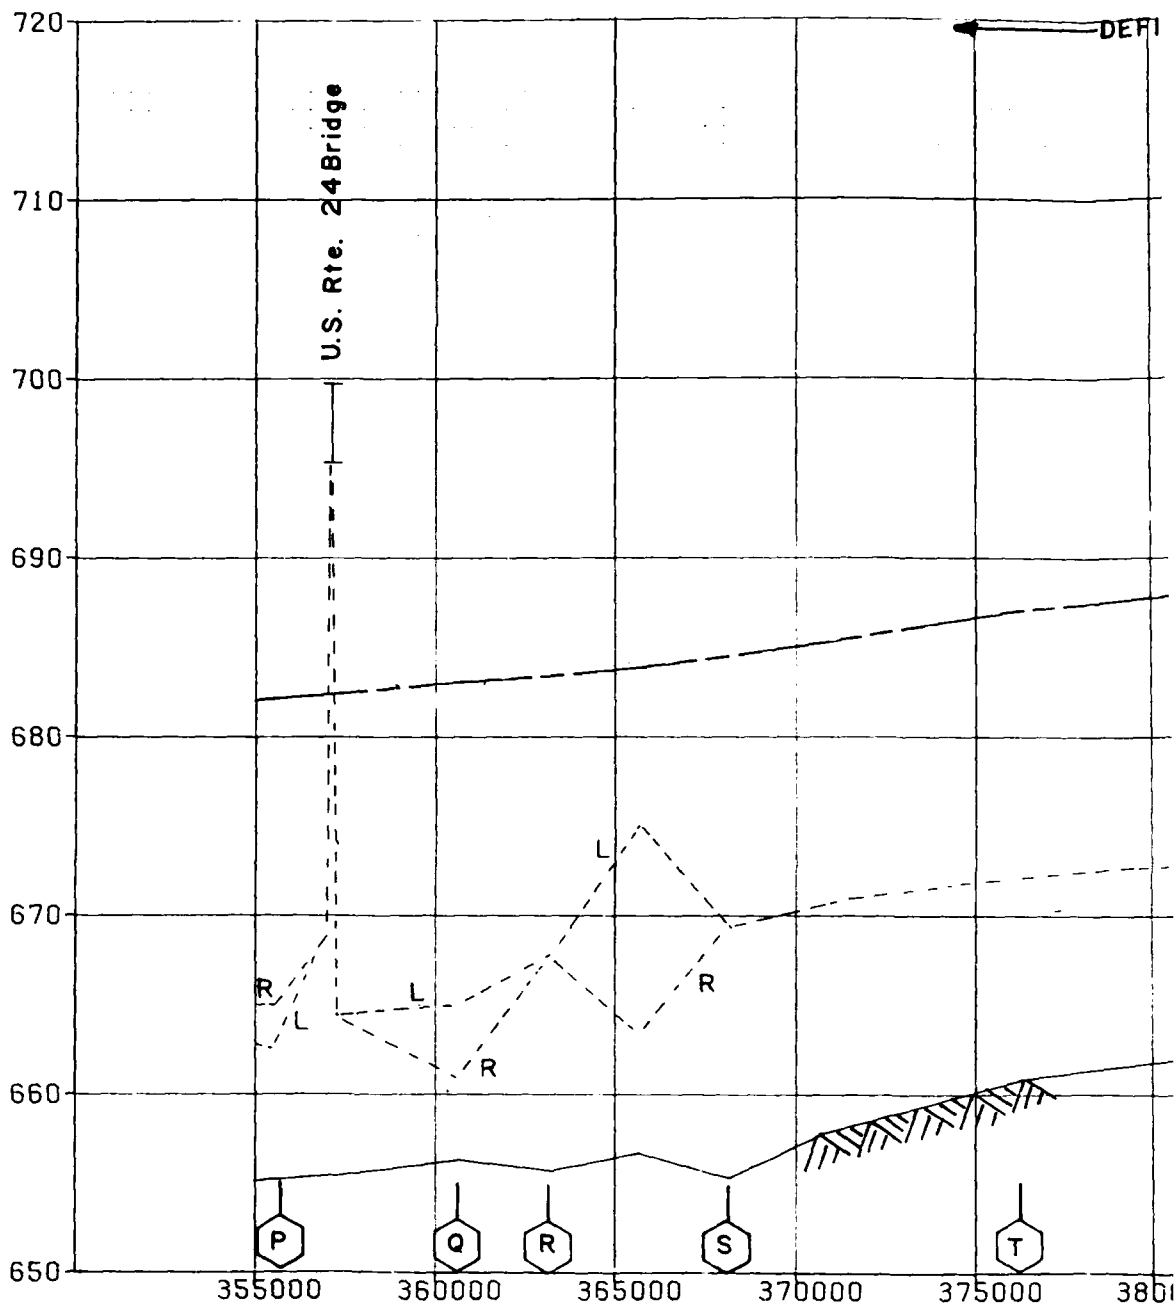
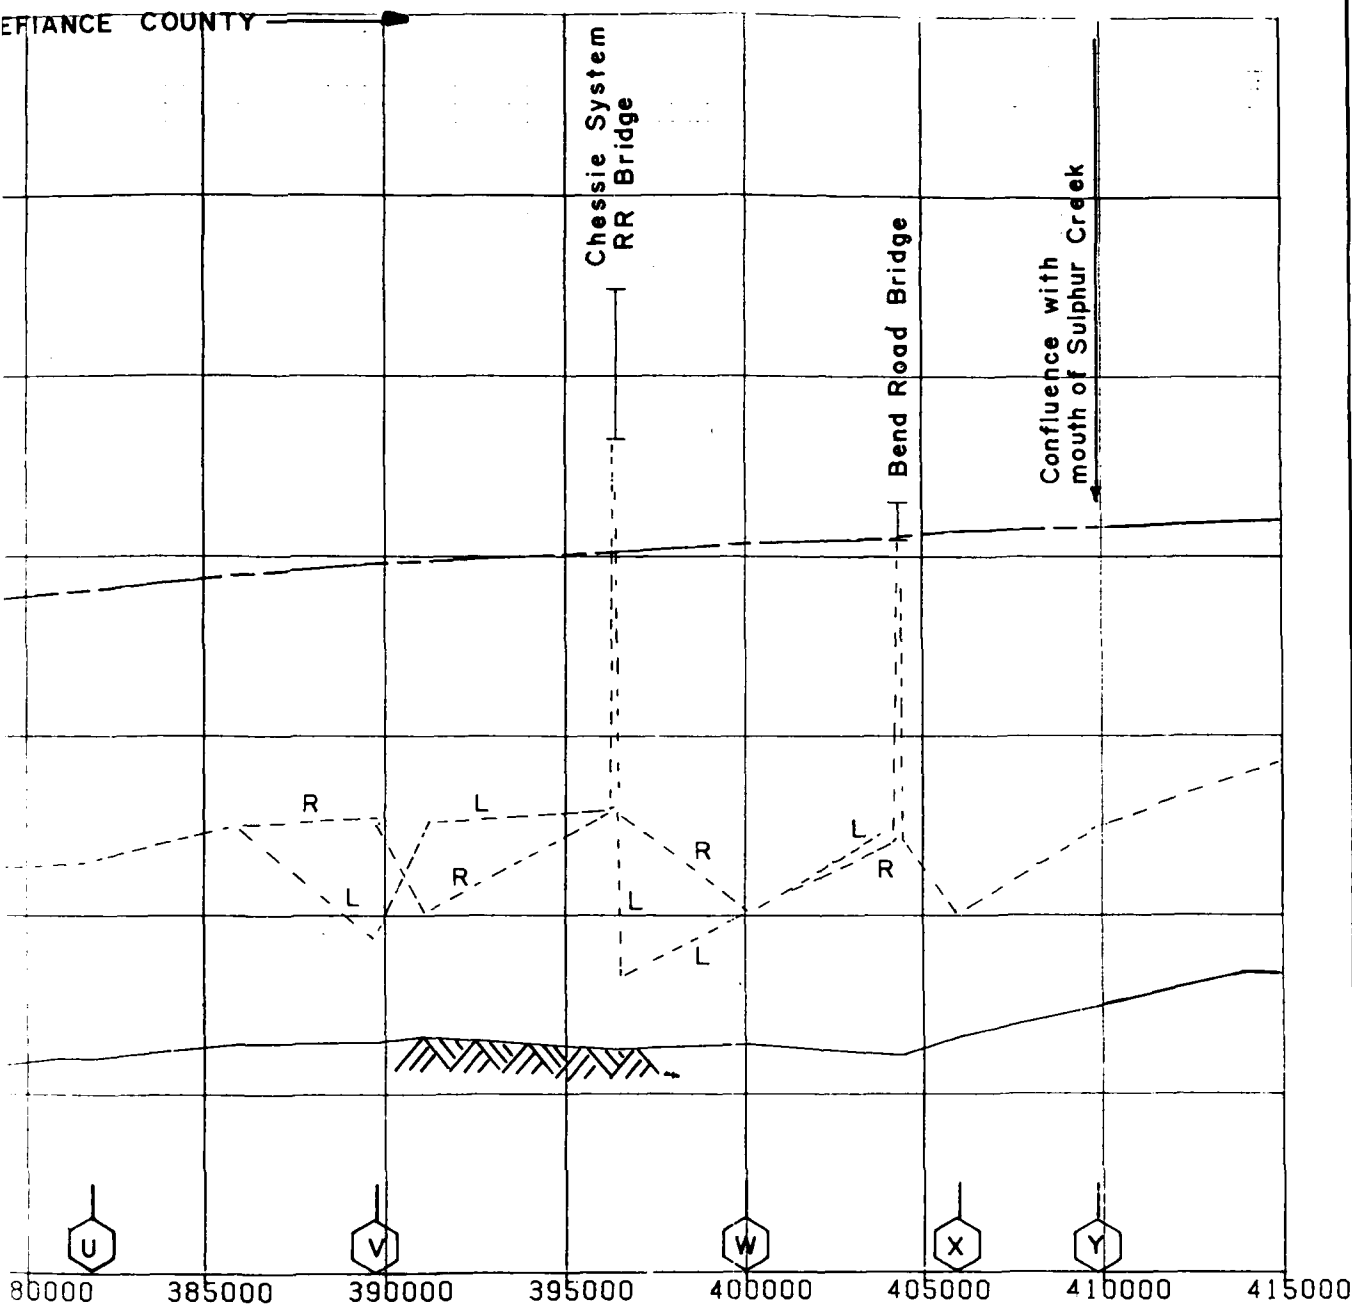
PLATE 2

FLOOD PROFILE

MAUMEE RIVER

STATION 3550+00 - 4150+00

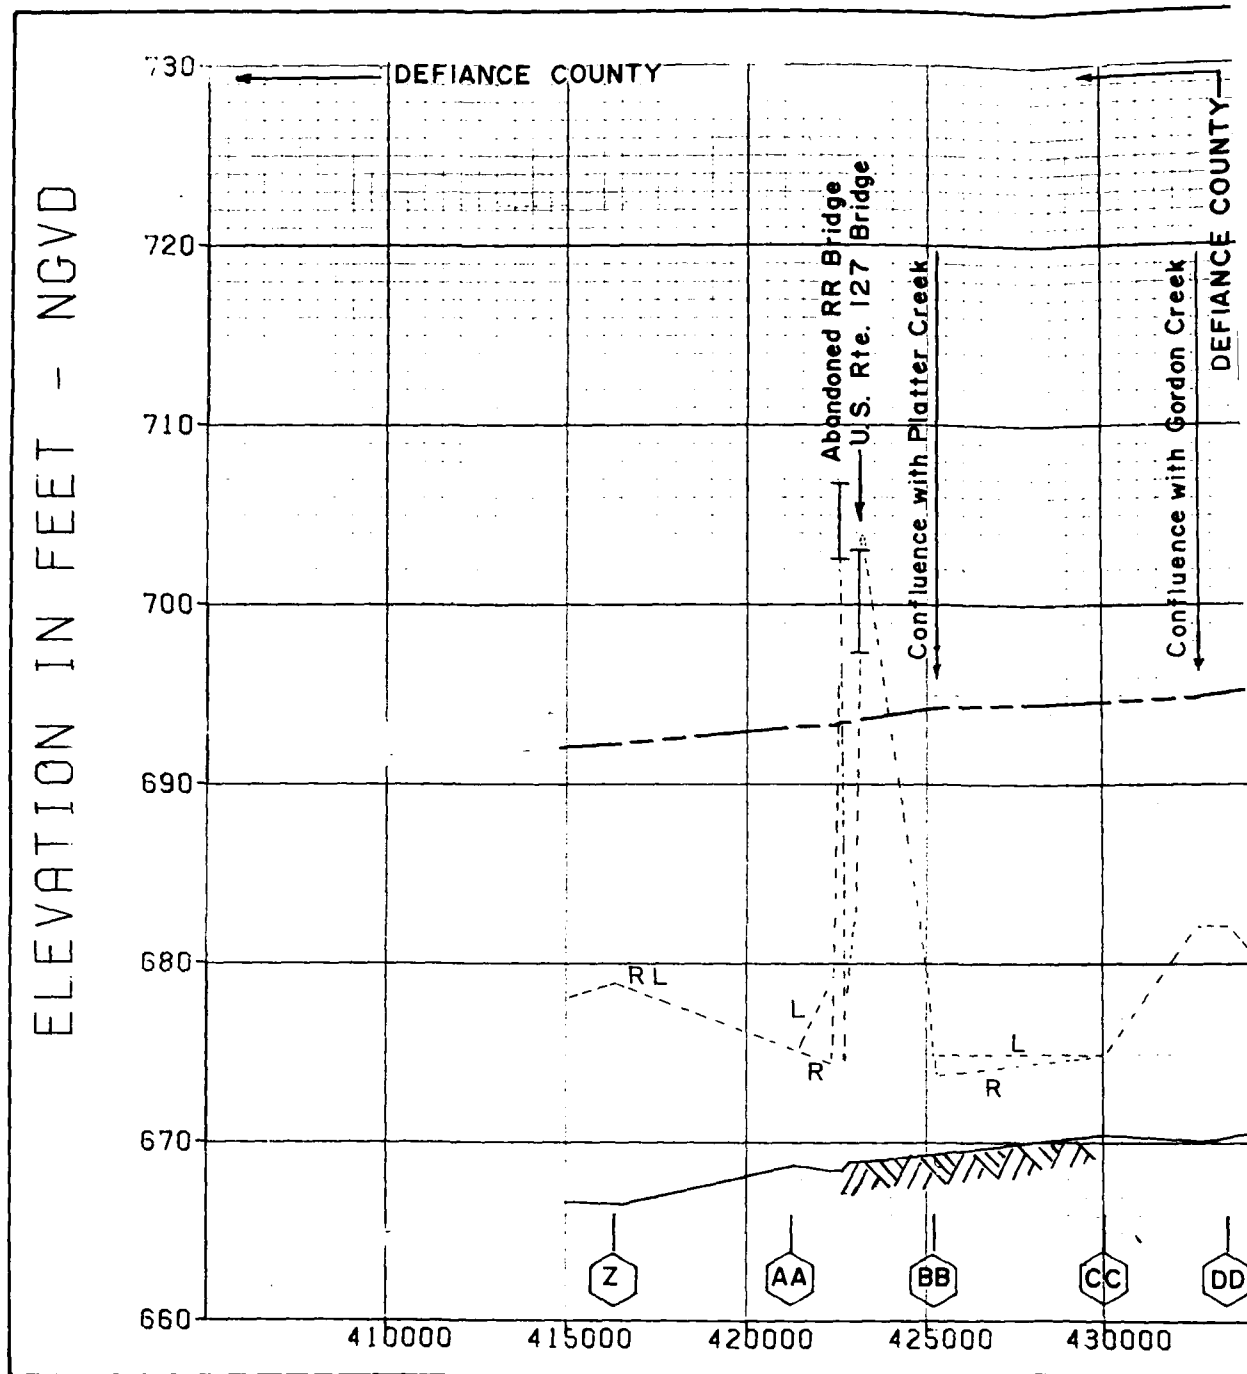
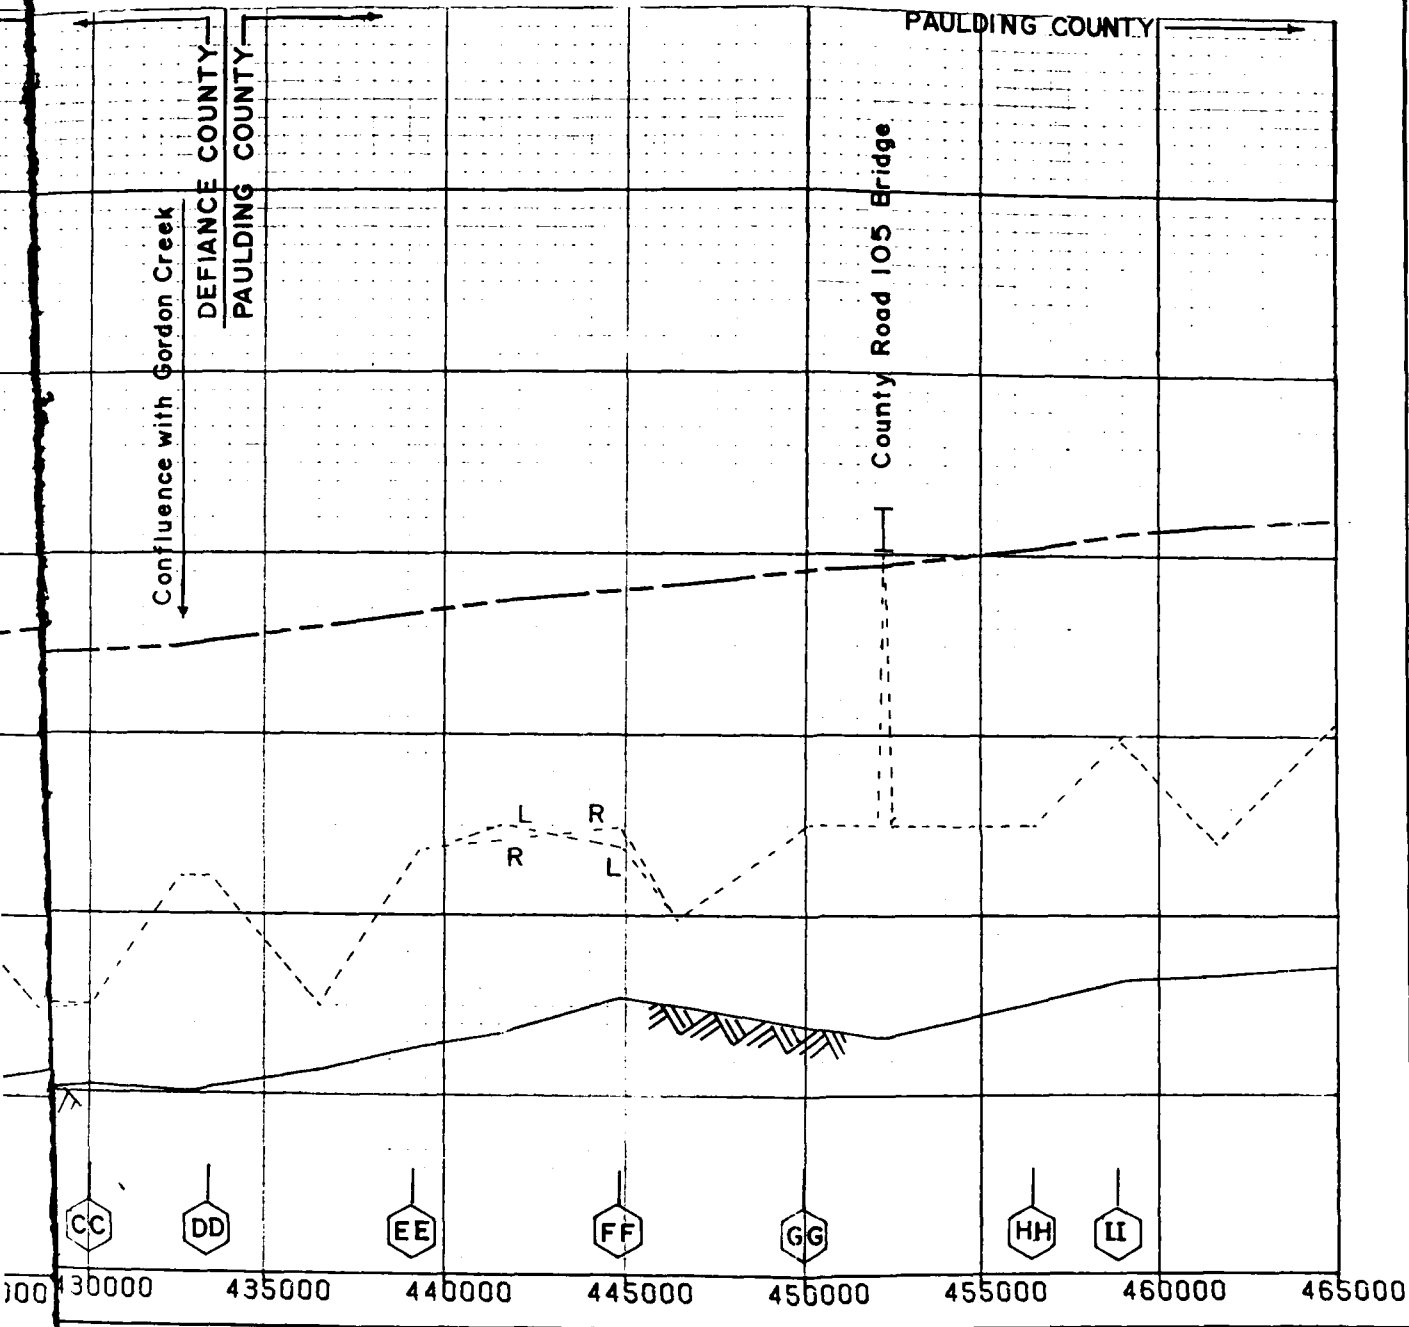
PLATE 3

NOTE: Distance is measured in feet from the mouth of Maumee River at Lake Erie.

FLOOD PROFILE MAUMEE RIVER

DEFIANCE AND PAULDING COUNTIES, OHIO
STATION 4150+00 - 4650+00

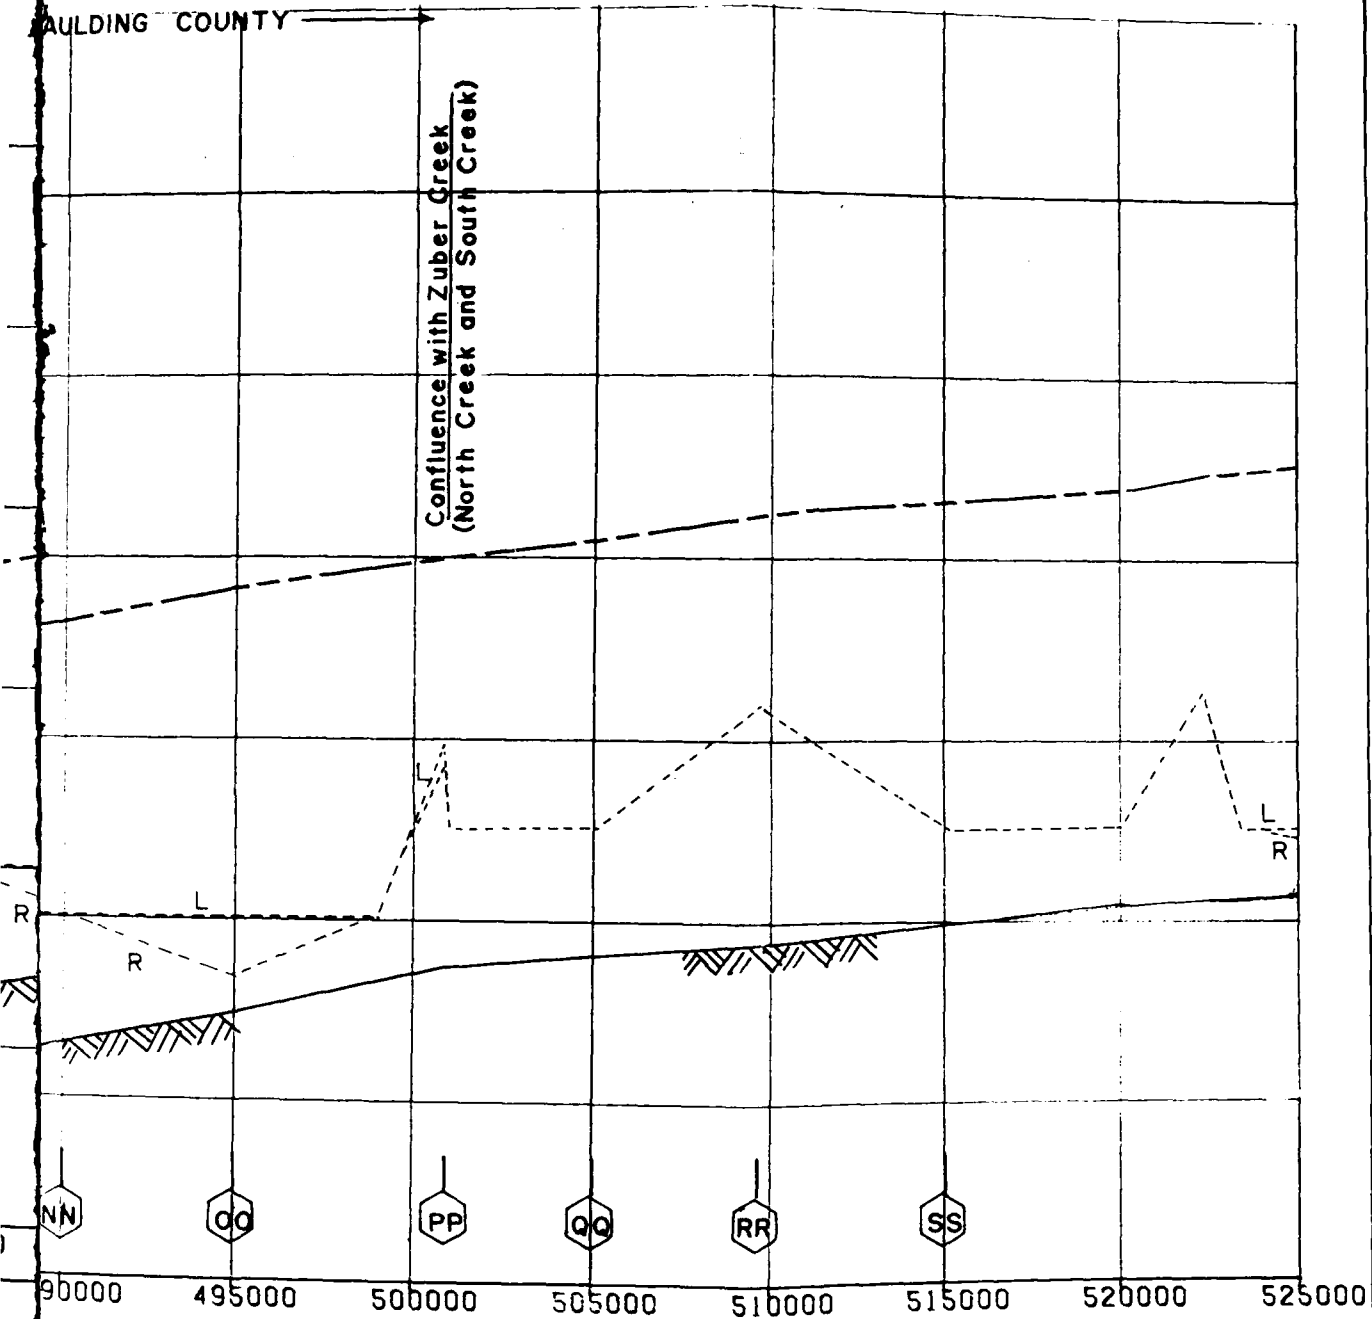
Distance is measured in feet from the
mouth of Maumee River at Lake Erie.

RIGHT BANK
LEFT BANK

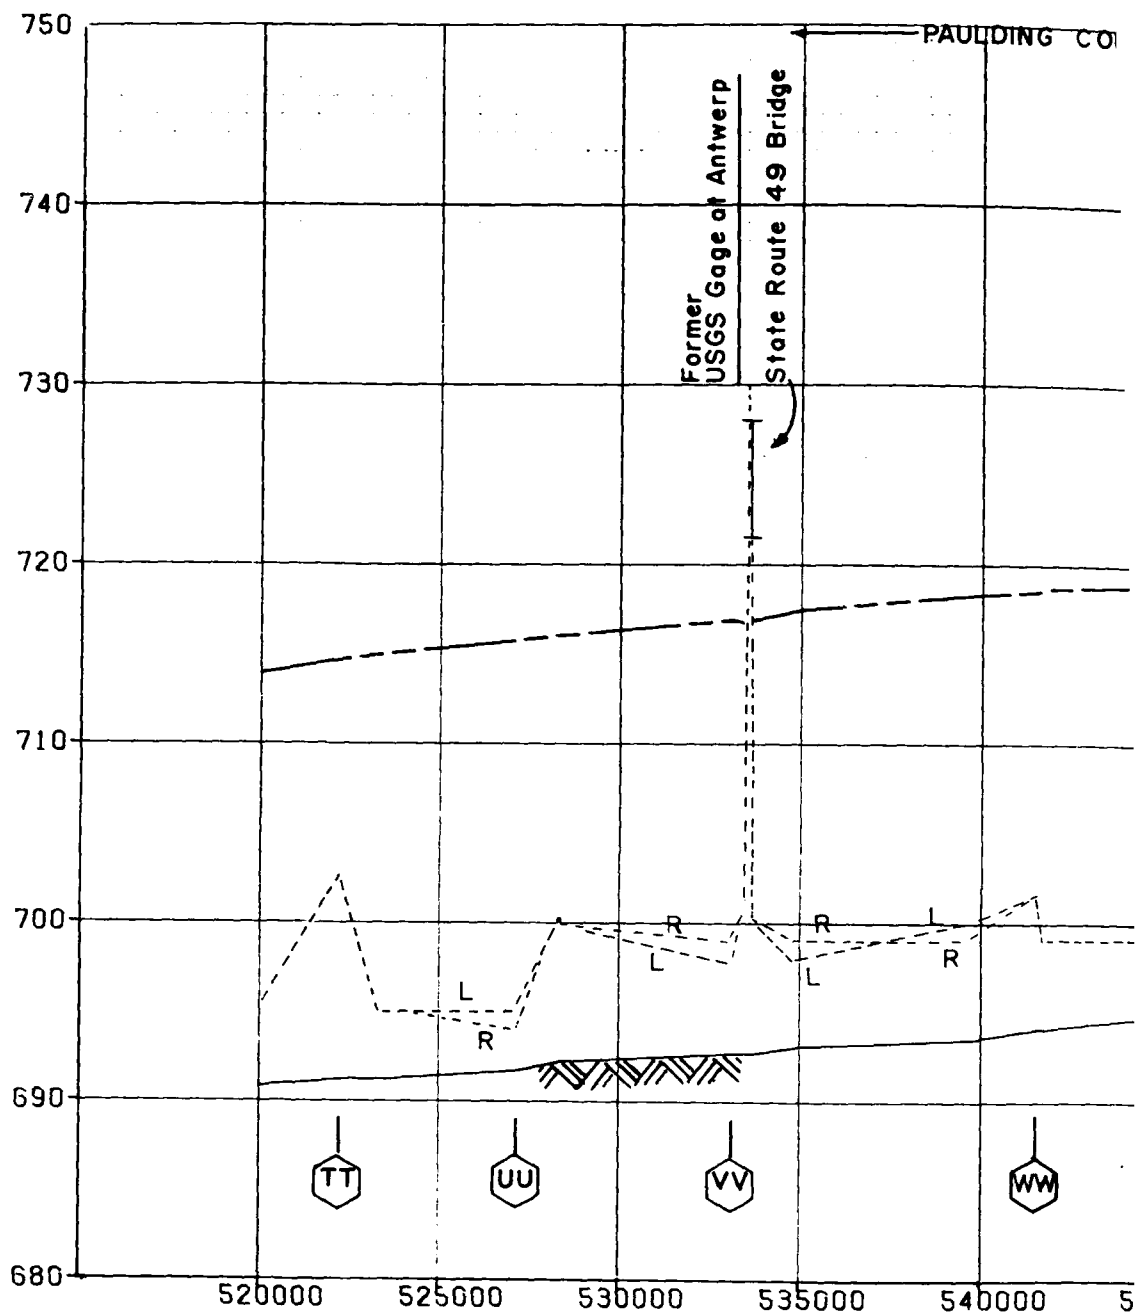
U. S. Army Engineer District, Buffalo
SPECIAL FLOOD HAZARD EVALUATION
FLOOD PROFILE
MAUMEE RIVER
 DEFIANCE AND PAULDING COUNTIES, OHIO
 STATION 5250+00 - 5720+00
 PLATE 5 SEPT. 1988

----- 100-YEAR FLOOD

The hydraulic analyses for this study are based only on the effects of unobstructed flow. The flood elevations shown on the profiles are thus considered valid only if the bridges remain unobstructed from debris or ice and if channel and overbank conditions remain essentially the same as ascertained during this study.
